MEMORANDUM

Re: Post-TCRA Quarterly Inspection Report - April 2013 Inspection

This document reports the results of the April 2013 quarterly inspection of the armored cap cover, fencing, and signage installed for the Time Critical Removal Action (TCRA) at the San Jacinto River Waste Pits Superfund Site (TCRA Site).

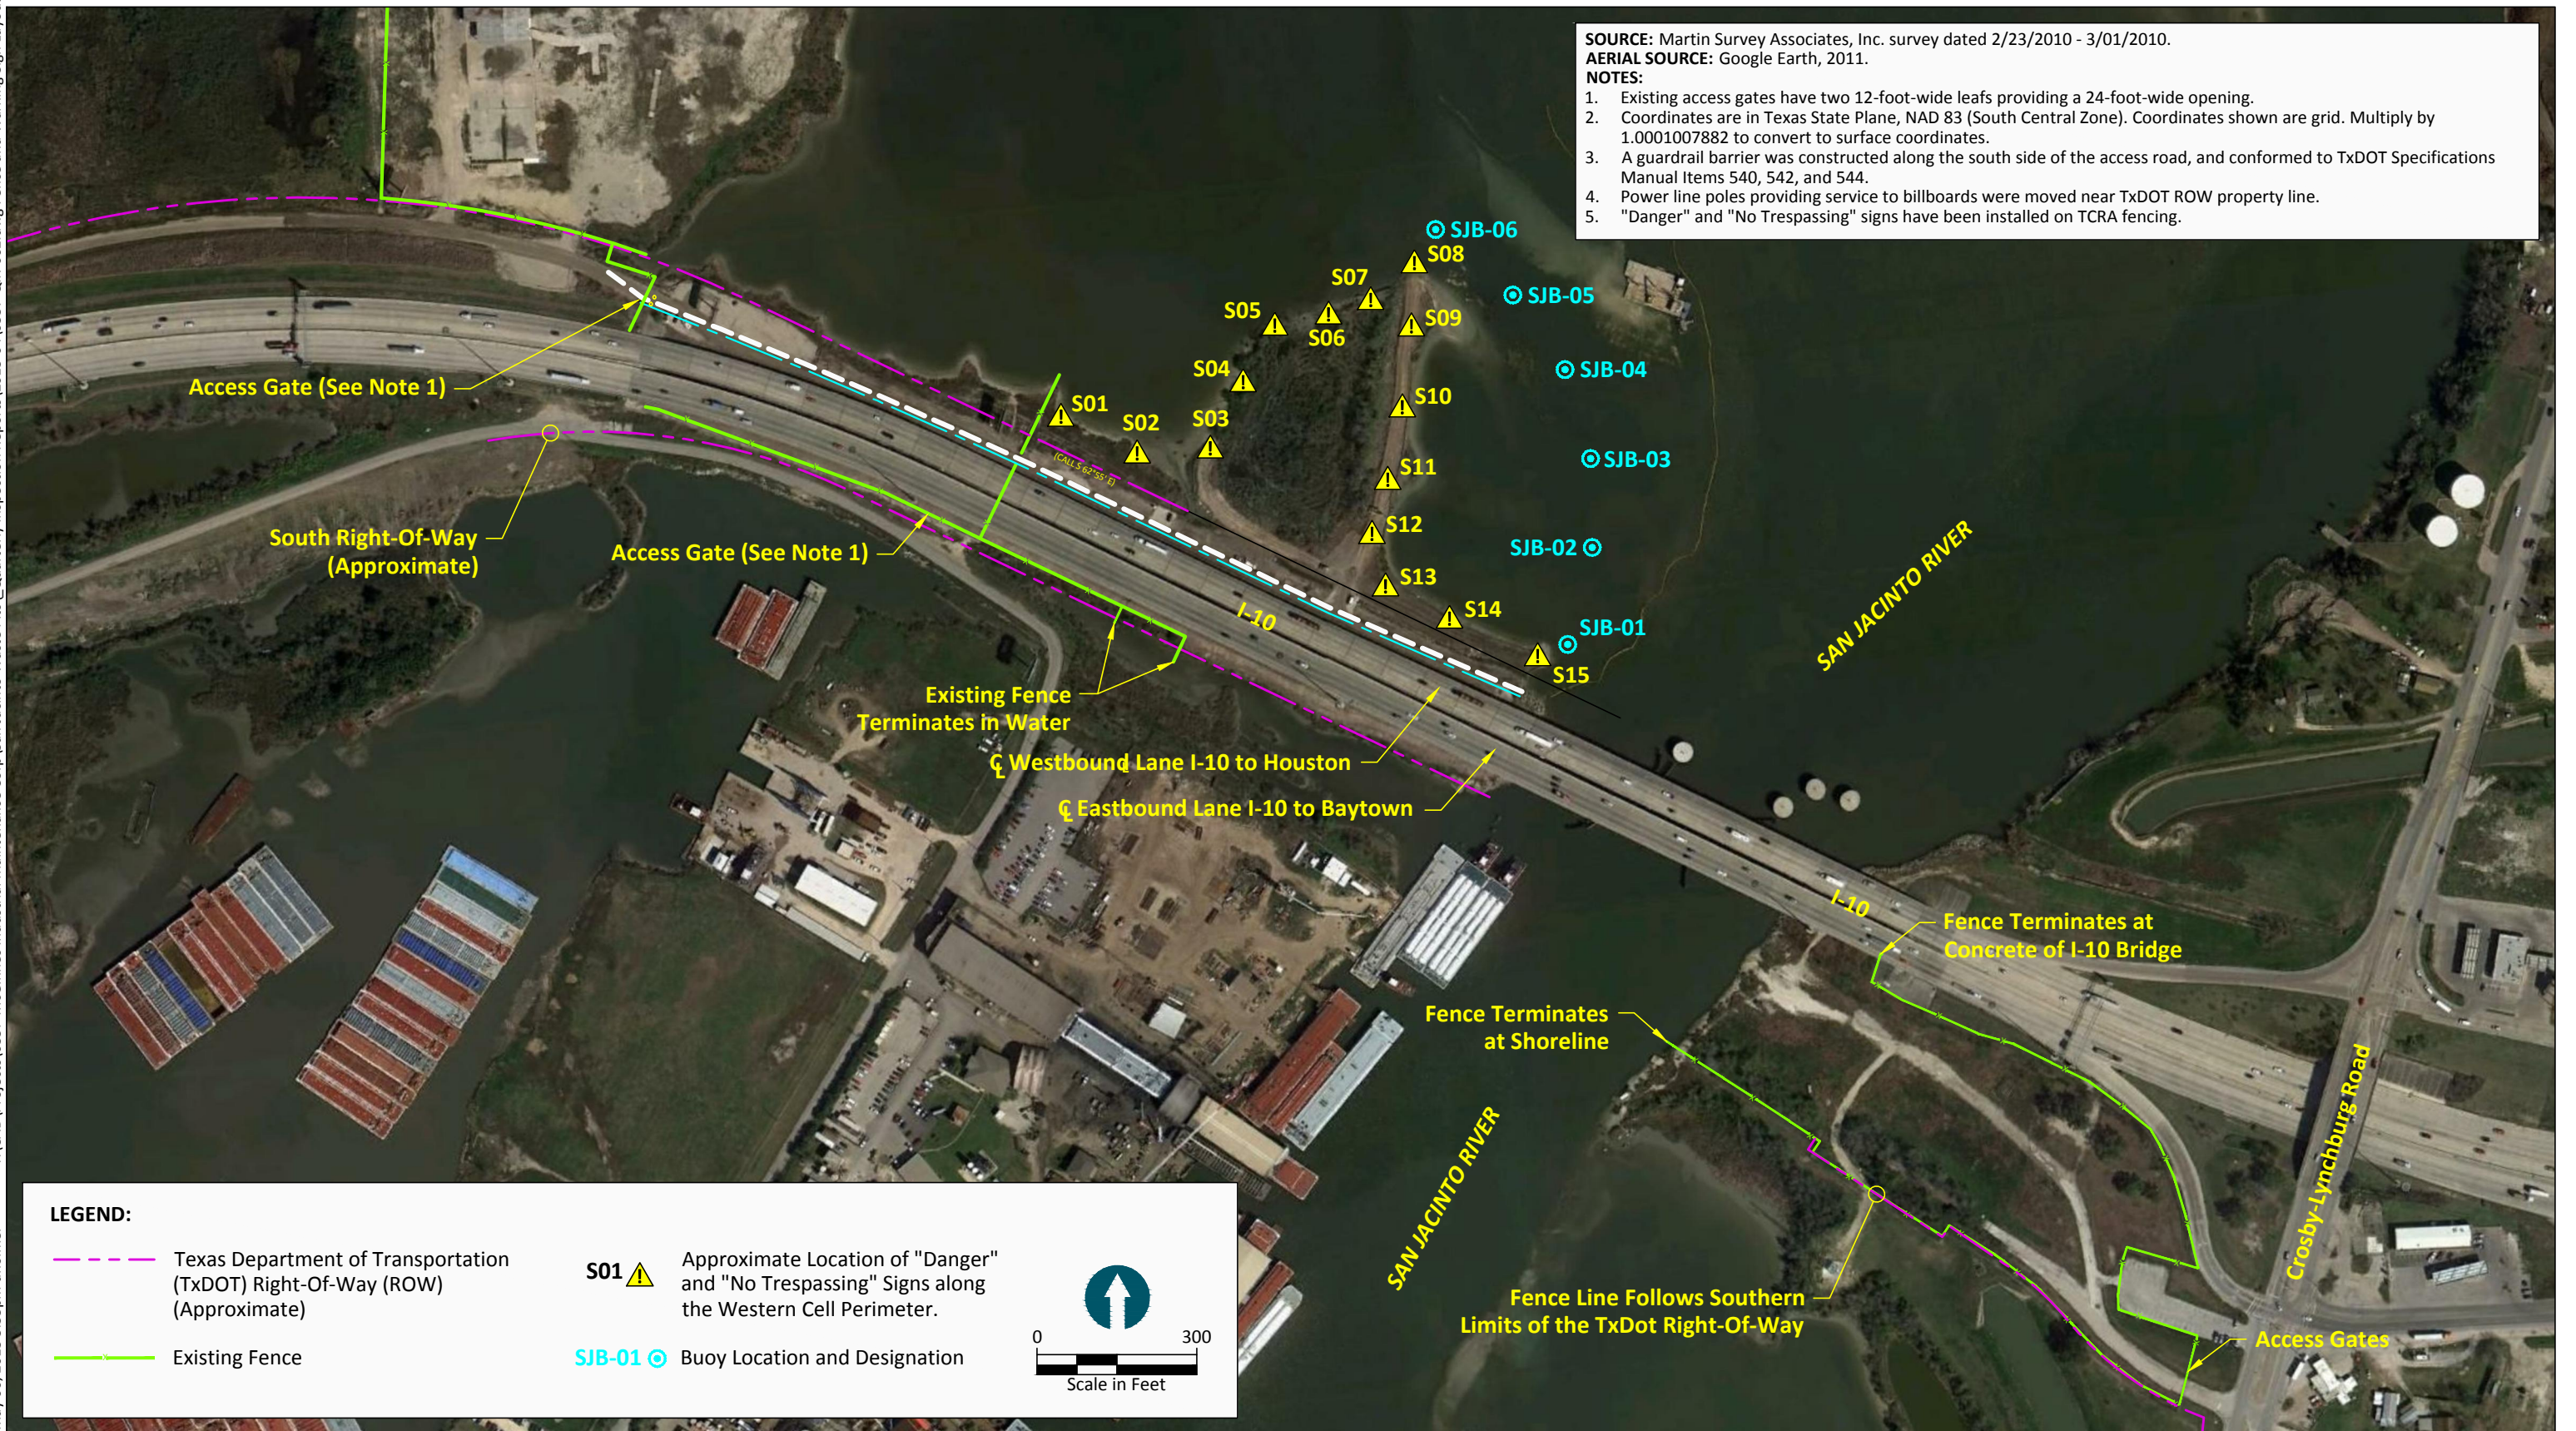
Figure 2 – Fence and Warning Sign Layout

The perimeter fencing (Figure 2) on the west and east banks of the San Jacinto River was visually inspected for breaches or other signs of damage on April 10, 2013. The inspection team paid close attention to the fencing on the west bank on the south side of I-10 where previous breaches had occurred. No breaches or other signs of fence damage were observed during this inspection for any of the three sections of the fence: the east bank, the west bank on the north side of I-10 or the west bank on the south side of I-10.

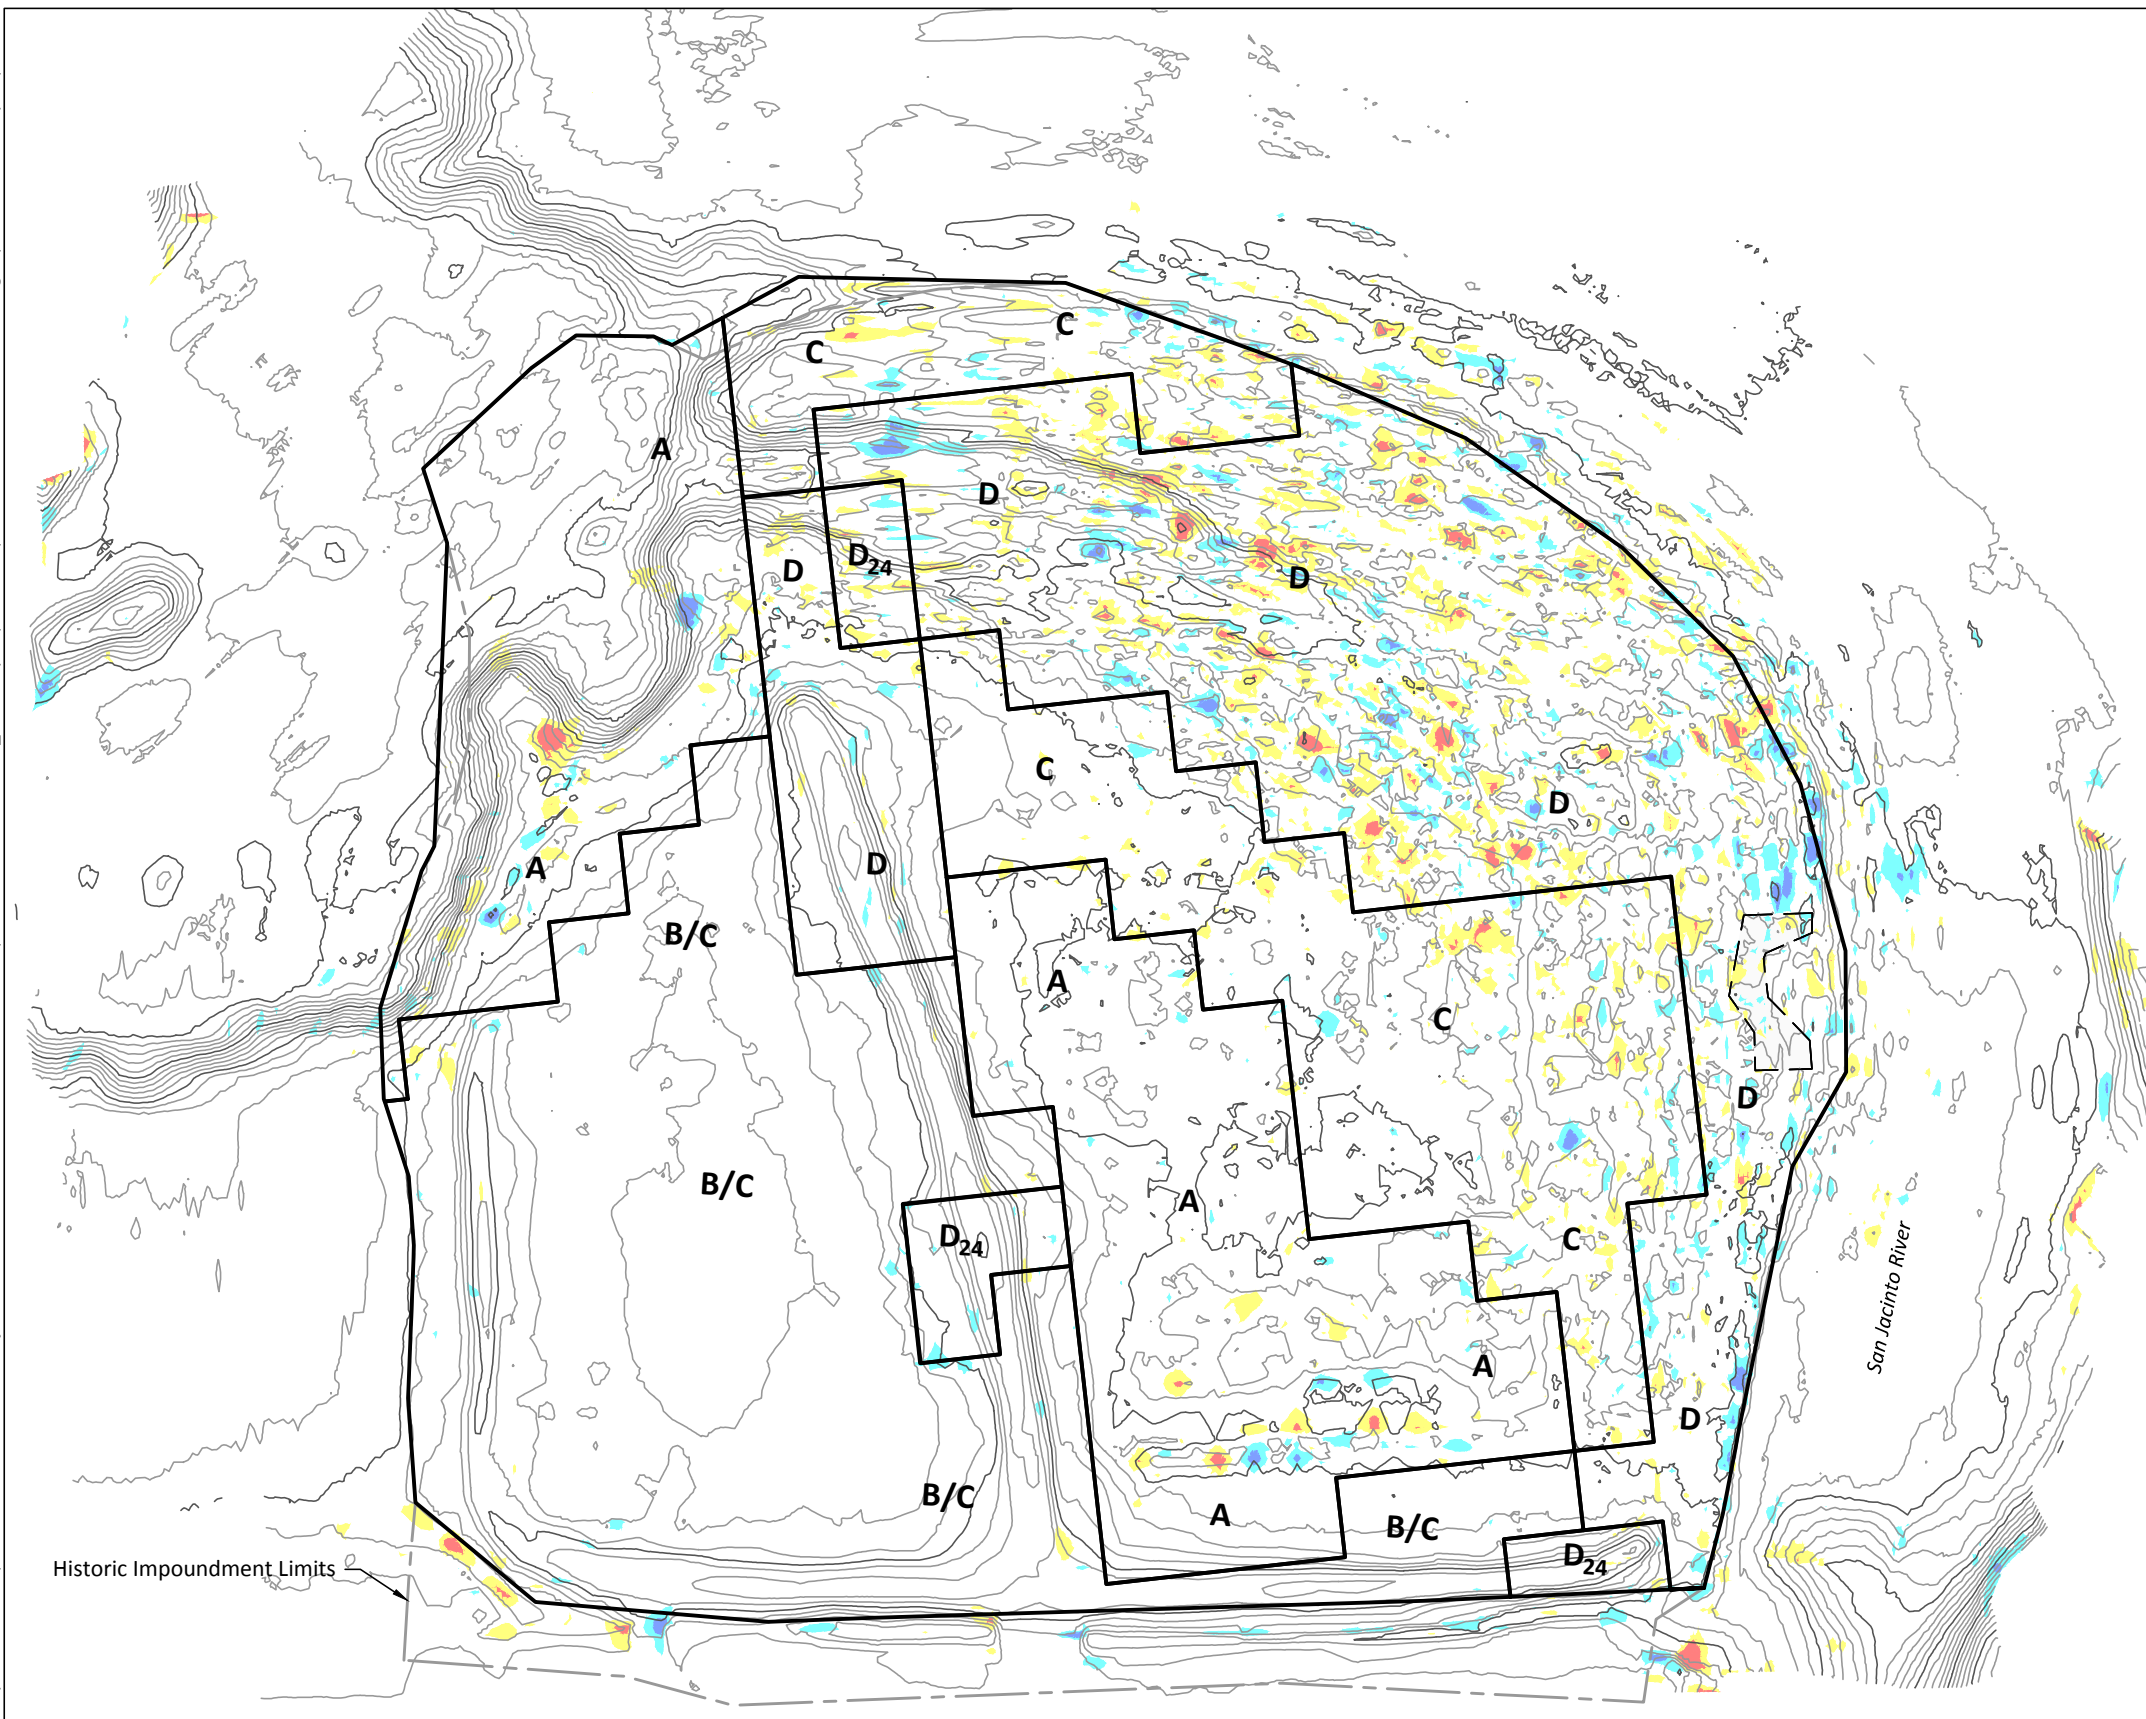
Figure 3 – April 2013 Quarterly Inspection Survey

This survey dataset was compared to the dataset from the previous quarterly inspection survey³ to evaluate the differences in the top of the armor cap elevation between surveys. These differences are shown on Figure 3. The survey results indicate there appears to be a substantial amount of new material being deposited on the surface of the armored cap, as may be expected in a fluvial system like the San Jacinto River. These results are also consistent with visual observations of the Eastern Cell during the January 2013 visual inspection during an extremely low tide event.

A small area in the intertidal zone was not safely accessible by either topographic or bathymetric methods (Figure 3) in the January 2013 survey, so a comparison between the January 2013 and the current survey dataset is not possible for that specific area. Seasonally high tides with south winds during the current survey period allowed a safe survey of this small intertidal area, and comparison of the October 2012 survey data with the current dataset indicates that changes in elevation of the armored cap have not occurred in this area between the two survey events.

No deficiencies were identified by the topographic or bathymetric surveys. With regard to the armored cap survey, the small areas identified as increases and decreases in elevation can be attributed to the horizontal and vertical accuracy of the survey, minor shifts in track line location from the baseline survey, elevation data recorded in the crevices between rock surfaces, or other related measuring inaccuracies. The potential for these inaccuracies to exist was confirmed by the surveyor after reviewing the data collected hydrographically during this inspection versus the walking surveys taken in January 2013 during an extremely low tide event.

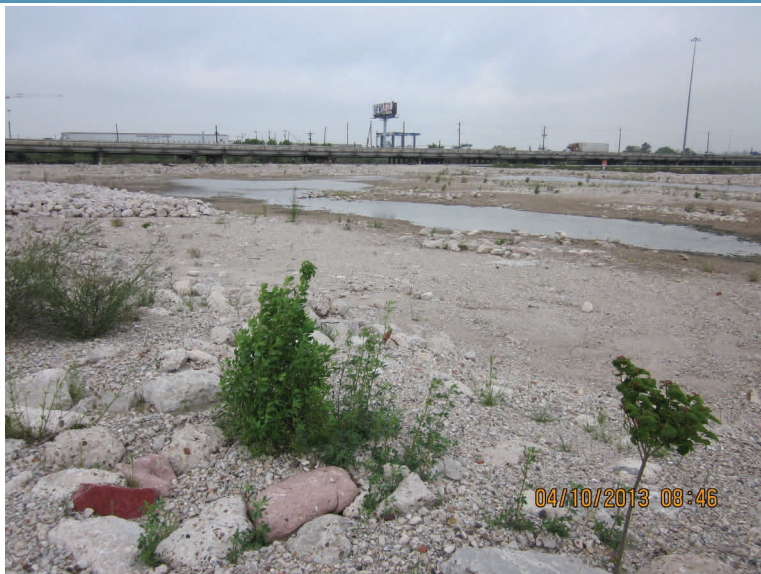
Photo 01: Western Cell from the central berm area (view southwest)

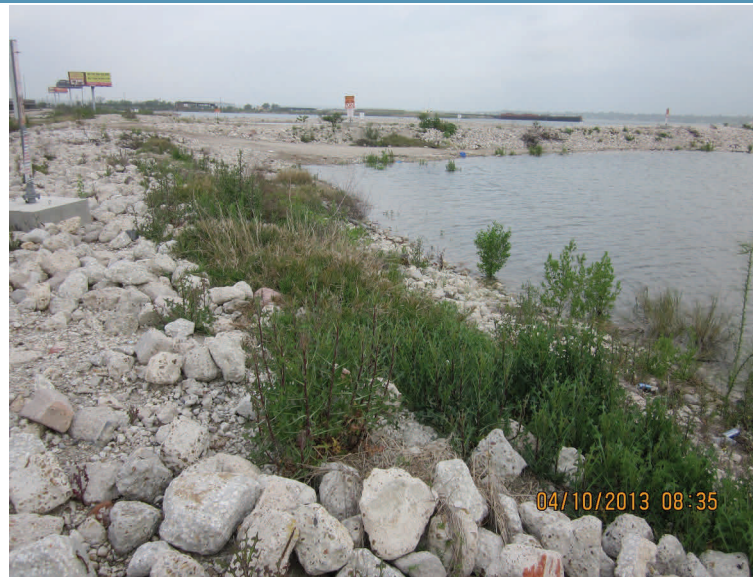
Photo 02: Vegetation and signage along southern and central berm (view northwest)

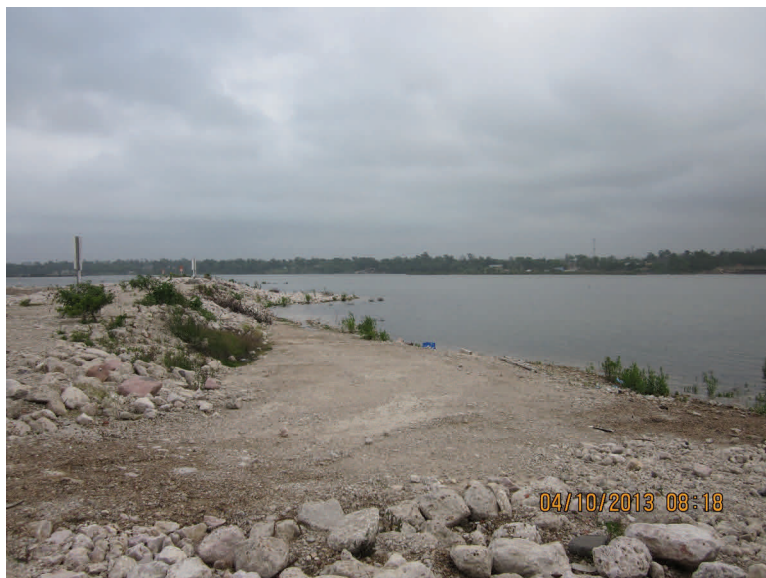
Photo 03: Eastern face of central berm as viewed from the intersection of the central and southern berms (view north)

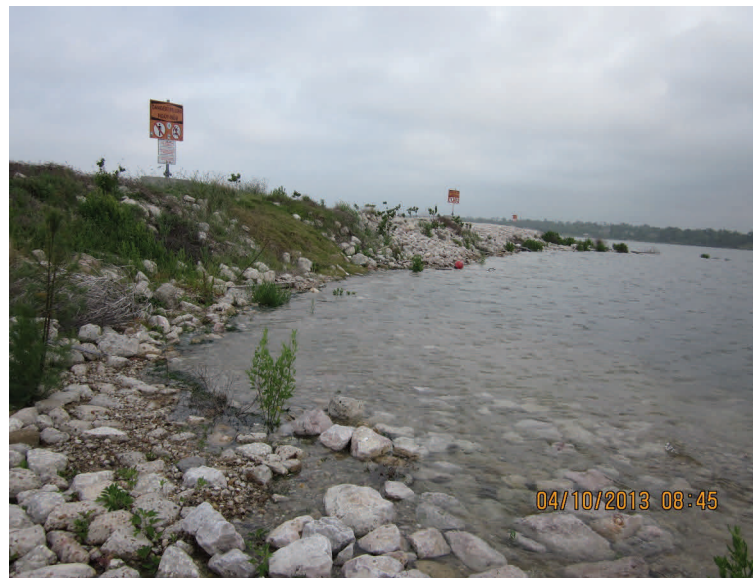
Photo 04: Central berm as viewed from eastern cell (view north)

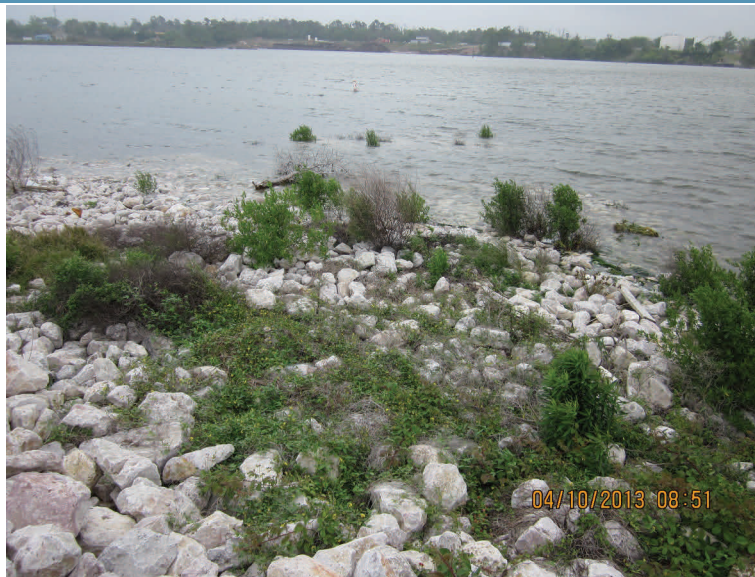
Photo 05: Vegetation on northern end of the Eastern Cell and warning buoy (view northeast)

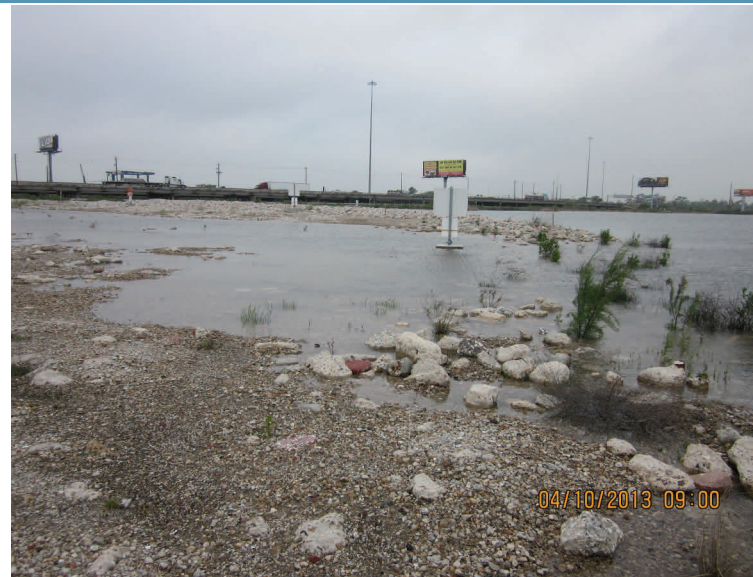
Photo 06: Northern edge of Western Cell submerged during high tide (view southwest)

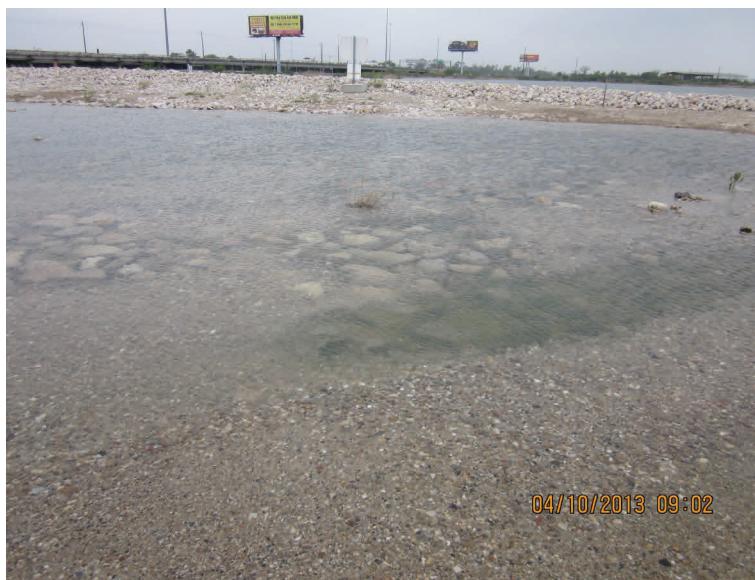
Photo 07: Northern interior portion of Western Cell with biological growth in submerged areas (view southwest)

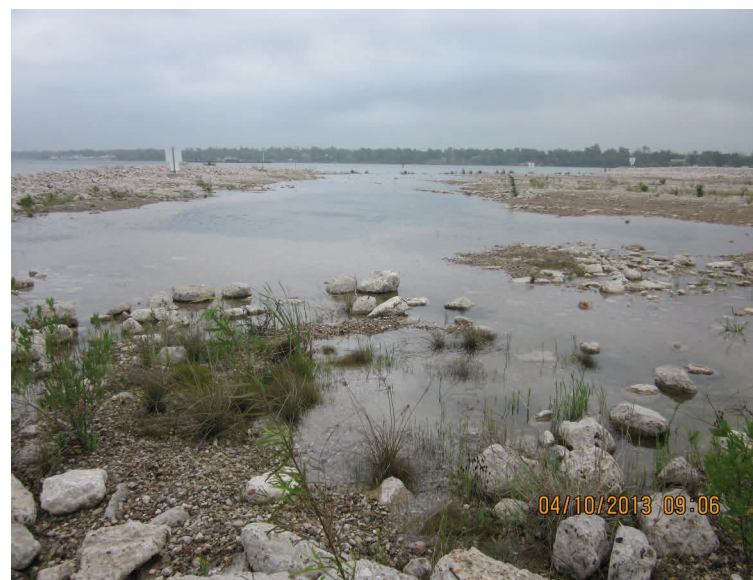
Photo 08: Northern interior portion of Western Cell that is submerged due to high tide (view north)

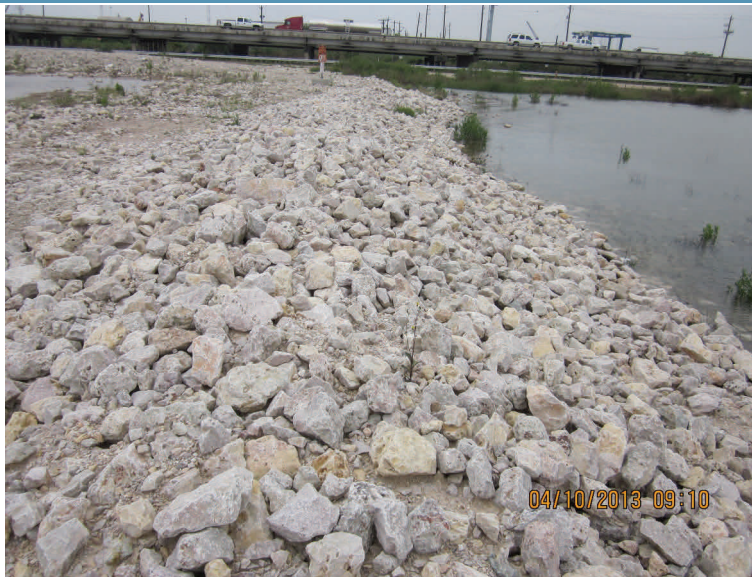
Photo 09: Southern end of the western berm (view south)

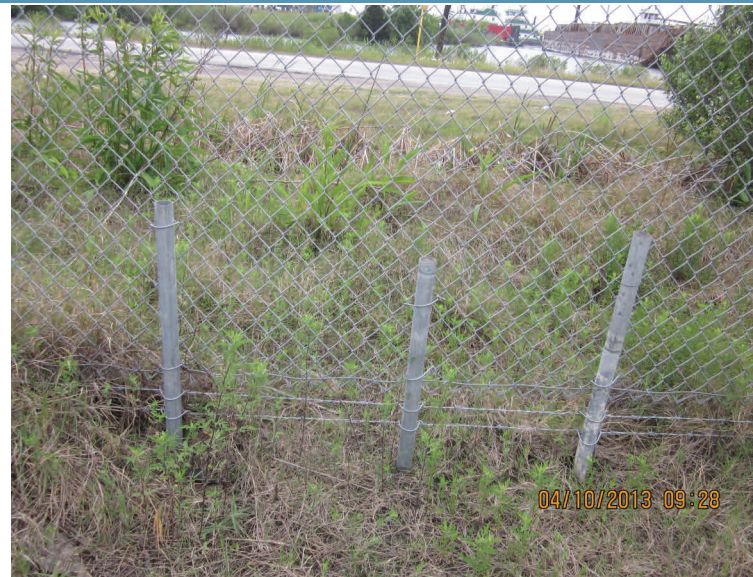
Photo 10: Additional lower supports and barb along perimeter fencing on west bank south of I-10 (view south)

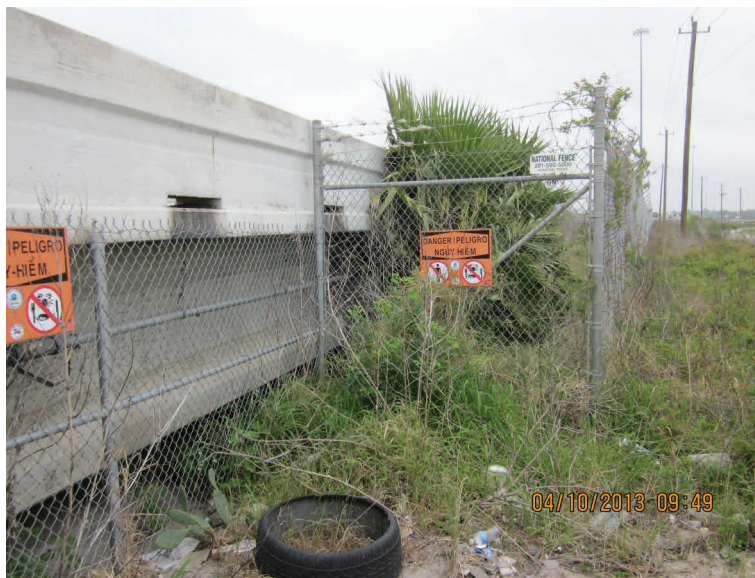
Photo 11: Warning signs along perimeter fencing on west bank south of I-10 (view northeast)

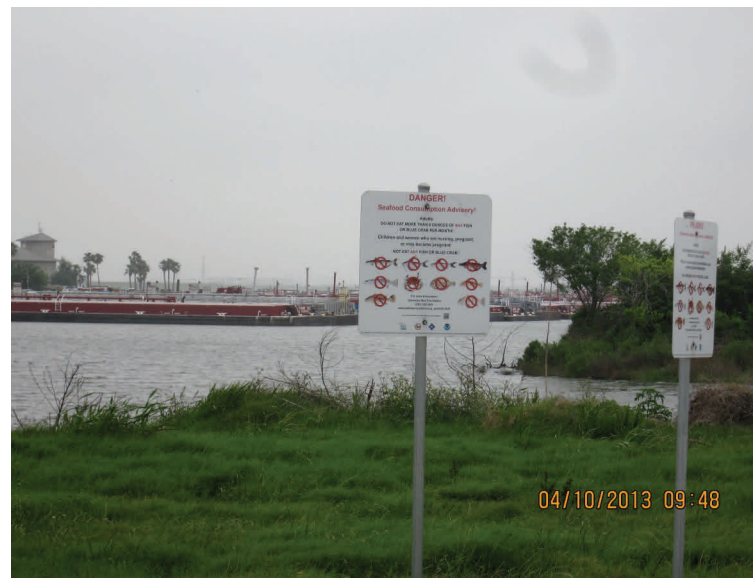
Photo 12: Fish consumption advisory signs on west bank south of I-10 (view south)

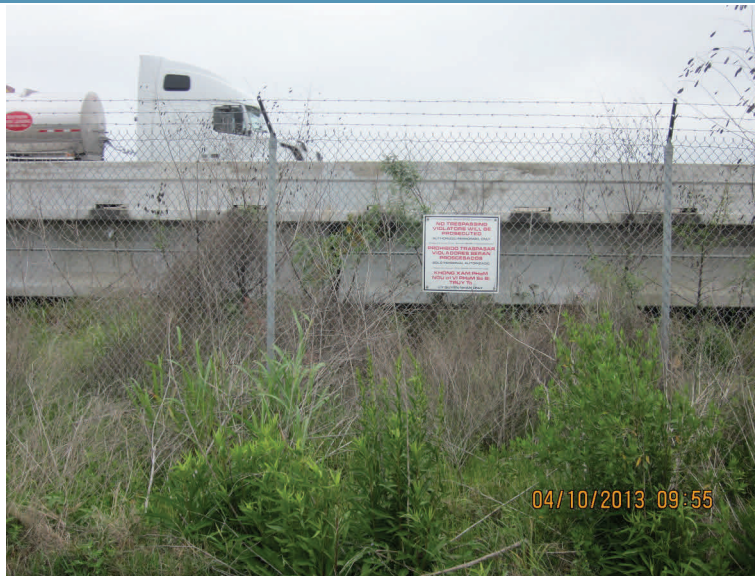
Photo 13: Warning signs along perimeter fencing on west bank south of I-10 (view north)

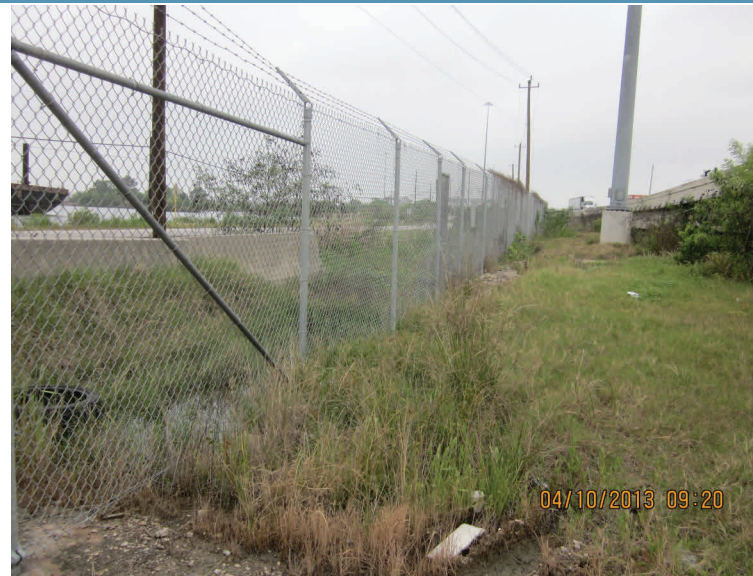
Photo 14: South fence line, west bank interior of the site (view west)

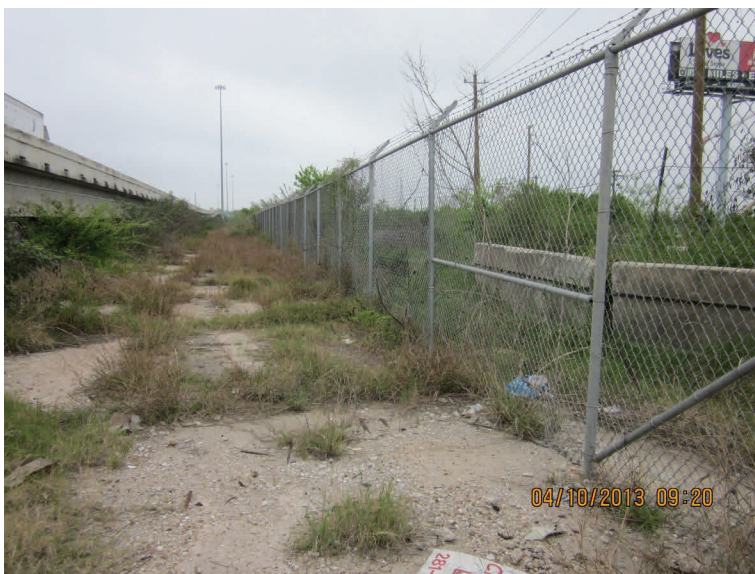
Photo 15: South fence line, west bank interior of the site (view east)

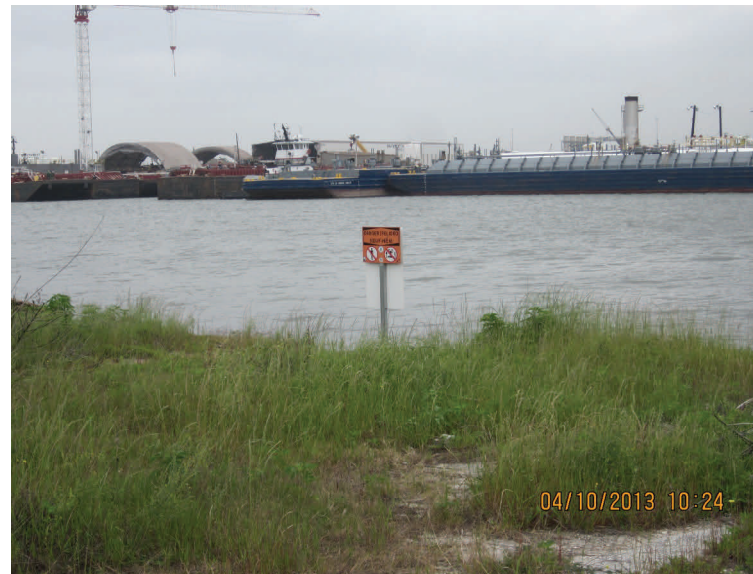
Photo 16: Warning sign on east bank of the San Jacinto River, south of I-10 (view west southwest)

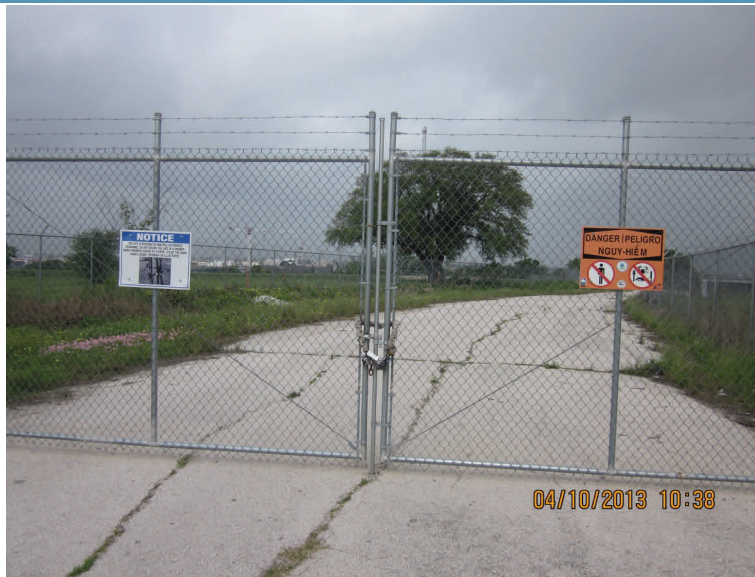
Photo 17: Daisy chain sign and warning sign on access gate to east bank south of I-10 (view southwest)

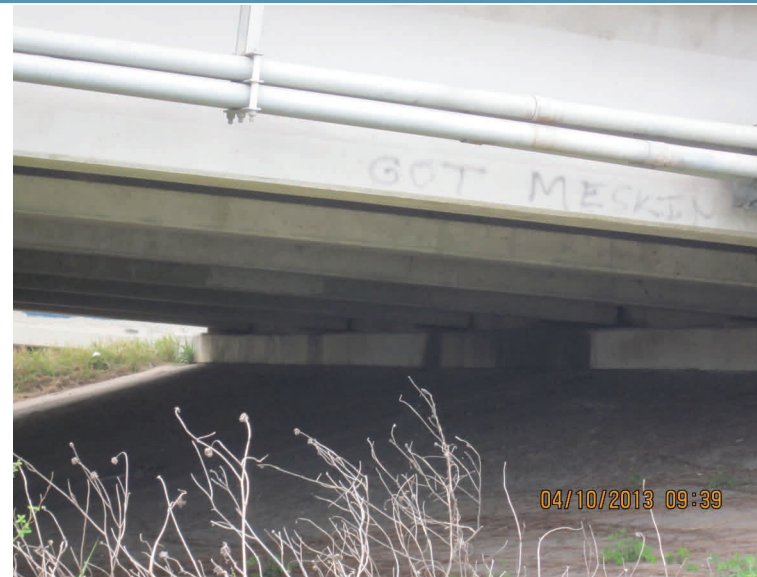
Photo 18: No signs people living under I-10 bridge west of San Jacinto River (view southwest)

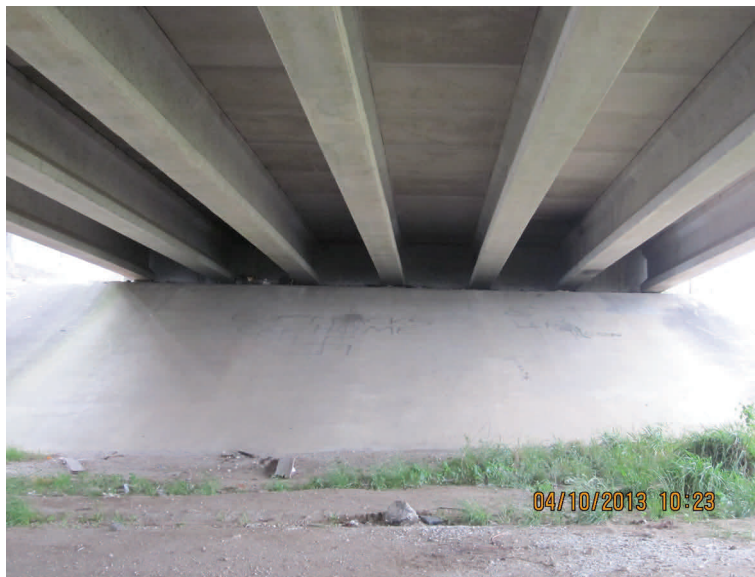
Photo 19: No signs of people living under I-10 bridge east of San Jacinto River (view east)

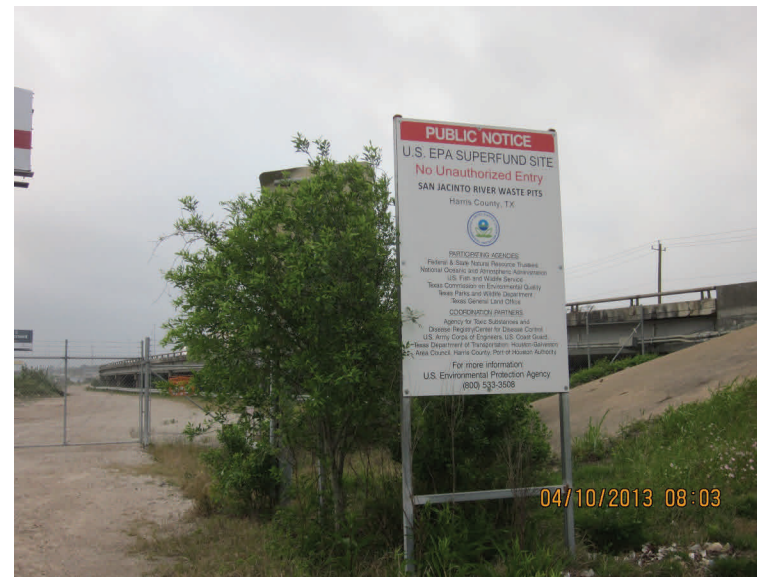
Photo 20: USEPA Public Notice sign located outside the access gate north of I-10 (view east)
